# Design & Build

Case Study 2

# House Renovation

# From Start to Finish

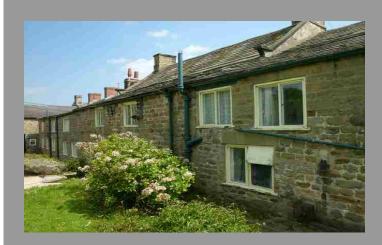
#### Picture 1

Before any work was started the house looked sad and down at heal. When we started work it became evident that it was even worse than this. The structure was so decayed that parts of it were at risk of collapse.

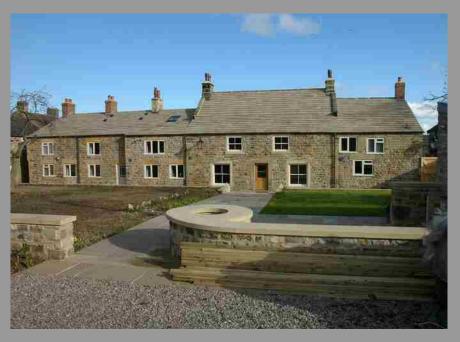
# Picture 2

Well advance into the project, new larger window openings are being created.
