## Design & Build

### Barn Conversion

### Case Study 1 Barn Conversion

#### THE STRUCTURE

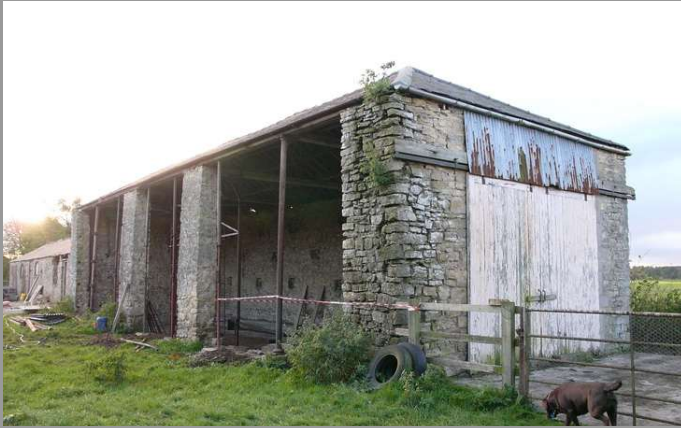
#### Picture 1

Whilst it looked solid enough on first sight, it was in fact riddled with structural problems. On this view you can see the inward leaning piers and the mortar leached out of the stonework. However, the roof is still good enough to retain.

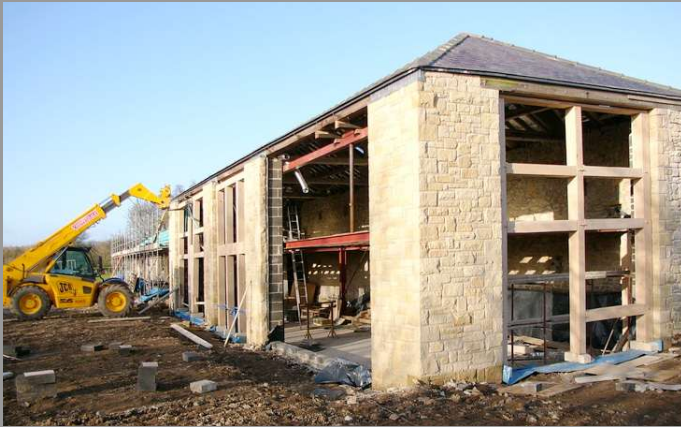
#### Picture 3

With high performing Danish windows installed, all the brand new services commissioned and working, and landscaping completed, this barn was ready for to provide modern living.

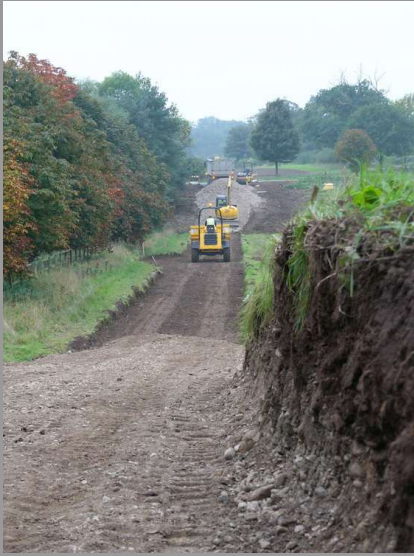
##### Picture 1

The first task was to build the drive to provide access

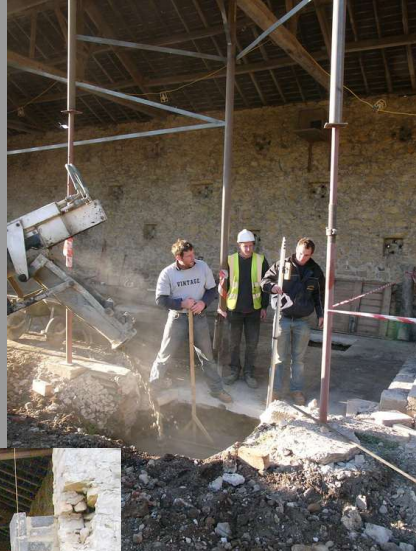
##### Picture 2

After the rotten walls and piers were demolished, new footings are poured. The rear wall was retained but under-pinned for its entire length.

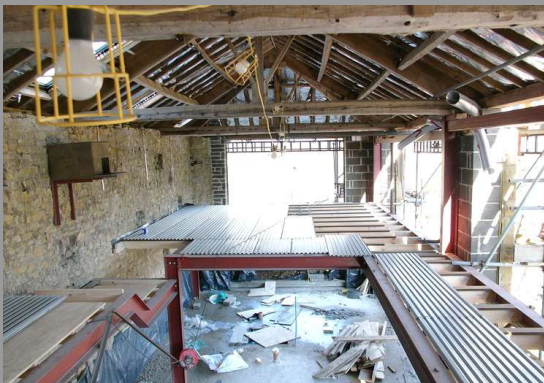
##### Picture 5

New roof well underway. Original trusses were repaired and retained. Conservation roof lights installed.
